**LTPP Seasonal Monitoring  
Program**  
Site Monitoring Suspension  
Status Report  
Section 371028  
Elizabeth City, North Carolina

# SEASONAL MONITORING PROGRAM SUSPENSION STATUS REPORT

## NORTH CAROLINA SECTION 371028

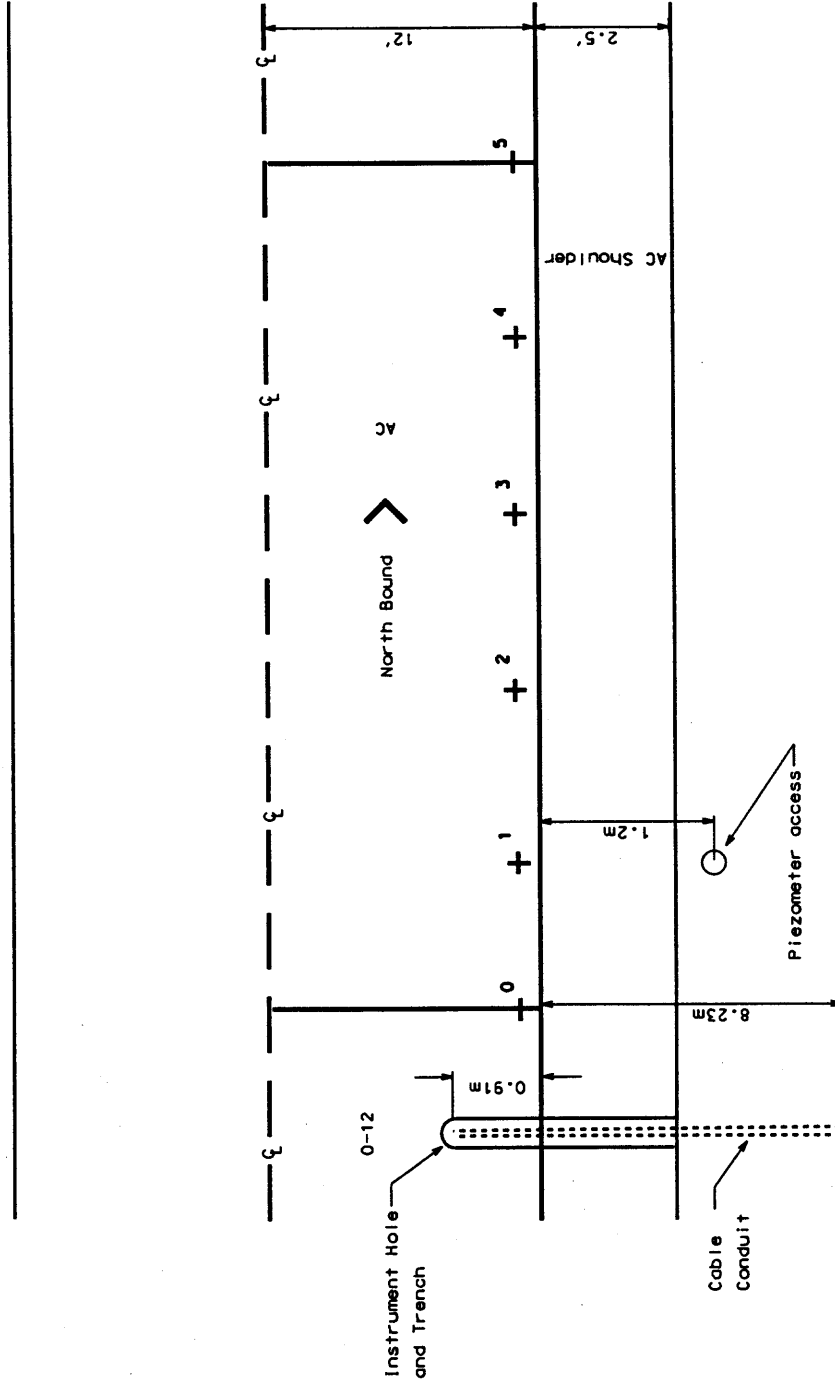
Figure 1. Plan view of Section 371028 -  
Post Suspension

Figure 1 shows the locations of the installed instrumentation at the site after close-out. The instrument hole is at Station 0-12 and the piezometer is at Station 1+00. Table 3 gives the elevations of the portion of test section 371028 that was used for elevation measurements. All offsets are measured from the PK nails found at the outside pavement edge.

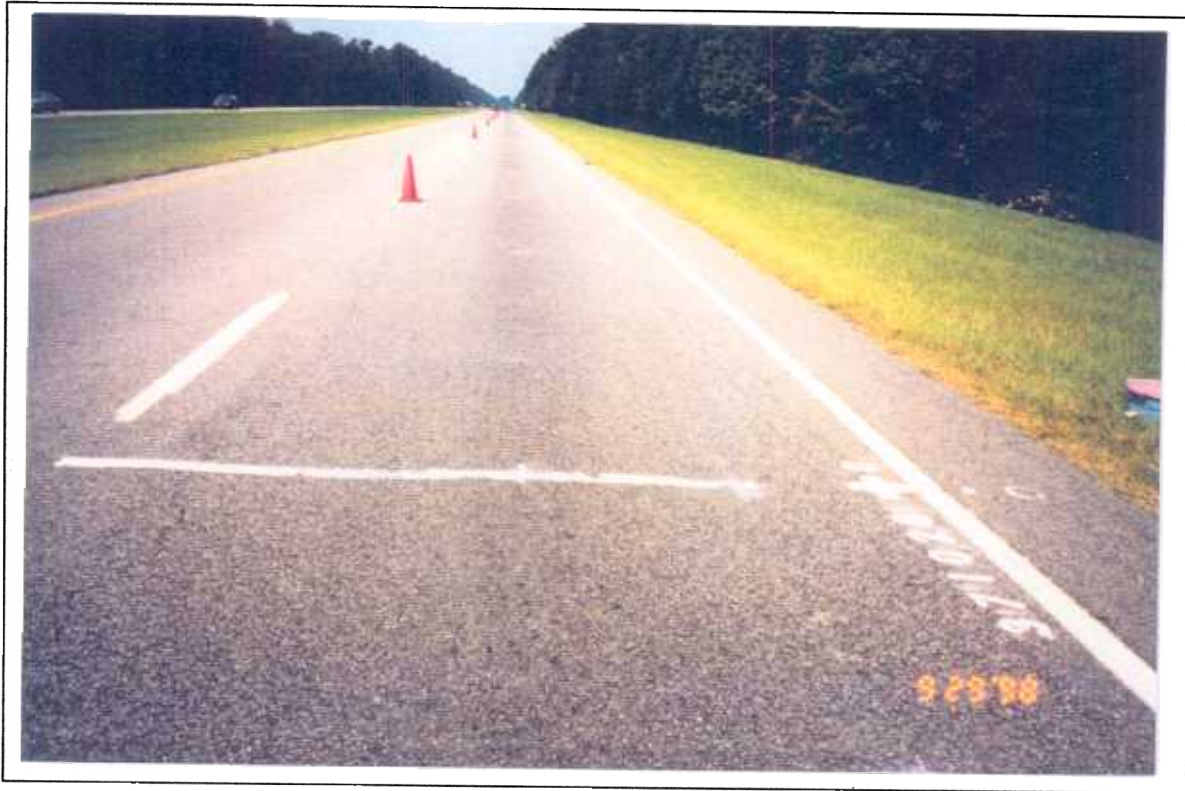
A manual distress survey of the entire section and cross profile surveys were conducted in conjunction with the SMP data collection at site 371028 on September 29, 1998. As is evident from the photo's, longitudinal wheel path fatigue cracking is evident in the wheel paths. Average rut depth measurements from the September 29 survey were 13.2mm in the left wheel path and 12.1 in the right wheel path. The site markings were refreshed at the time of the MDS survey.

Pavement Condition, Seasonal Site 371028, September 1998, Pre Suspension Activities

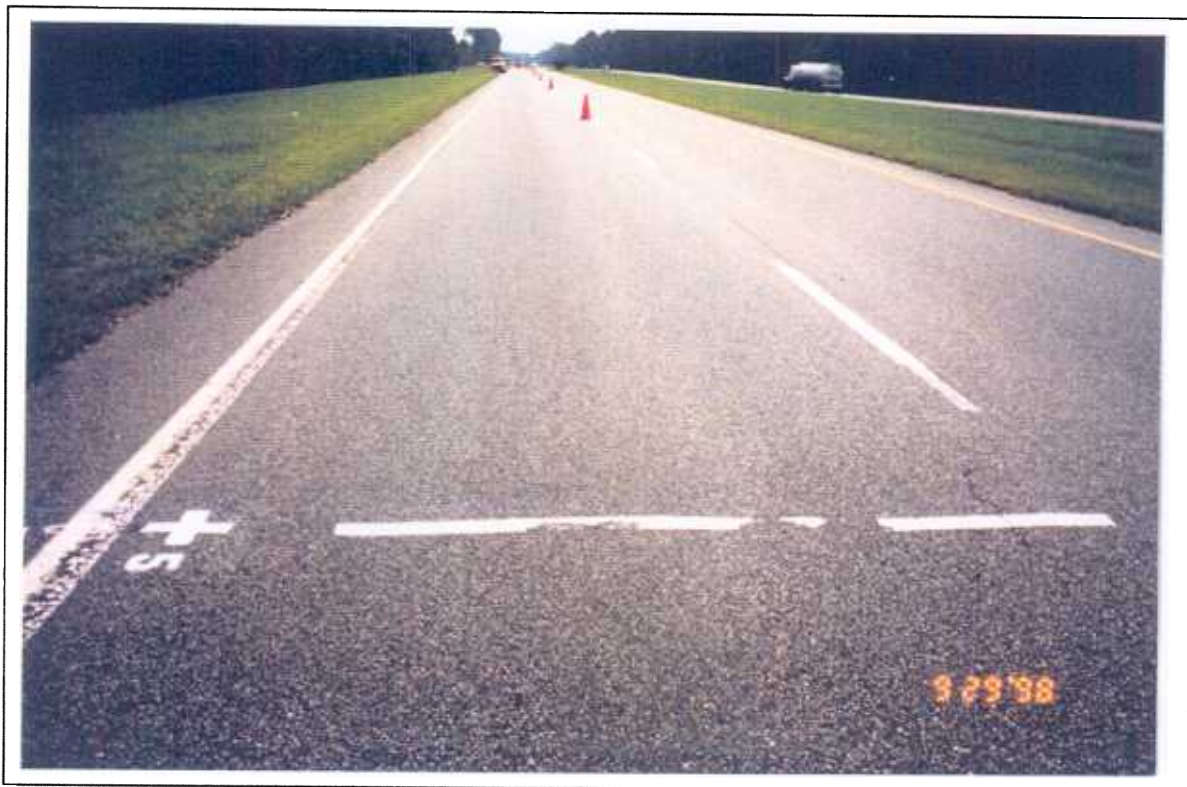
Pavement Condition, Seasonal Site 371028, September 1998, Pre Suspension Activities

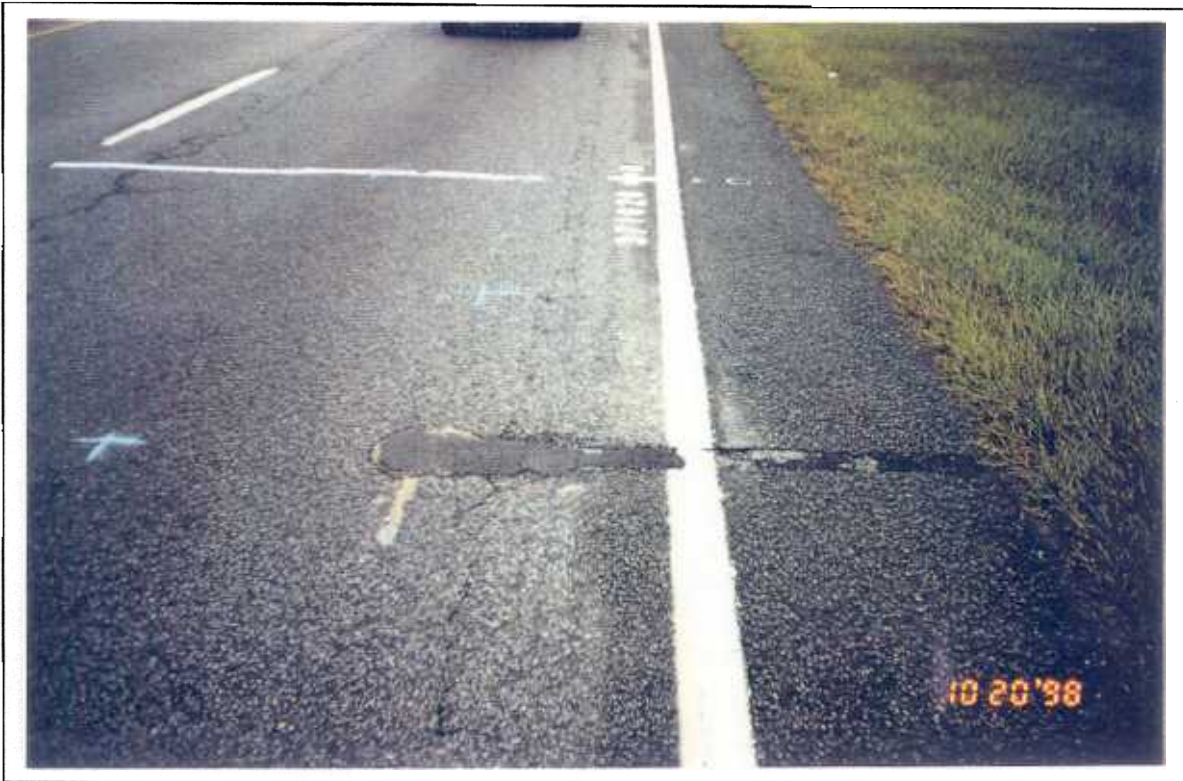
The removal/replacement of the material from the instrumentation hole was successful, with the material being well consolidated around the instrumentation. The surface friction coarse became unbonded from the core during the installation. This material was replaced with a thin cold mix patch bonded on the circumference with a mixture of sand and epoxy. The core was level with the existing pavement surface at completion.

Intrument Hole, Seasonal Site 371028, October 1998, After suspension Activities
